Safety Information

08.07.03

Concerning: rubber/metal composites with dimensions of $\text{Ø}50 \text{ mm} \times \text{Hight } 45 \text{ mm}$
and $\text{Ø} 40 \text{ mm} \times \text{Hight } 30 \text{ mm}$

used in the Monster and the Simonini motor and at the engine mount of the Flyke

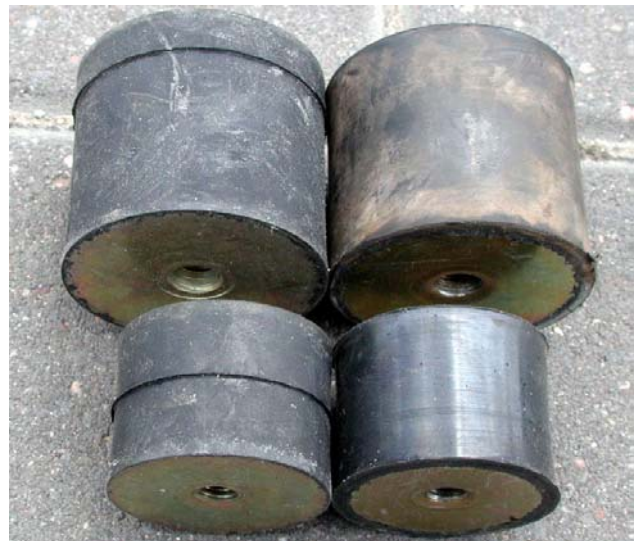
The above mentioned rubber/metal composites failed in the interface between rubber and metal at one Flyke and one motor. Additional tests proved that in some cases the adhesion between rubber and metal is not sufficient. The reason for that is still under investigation.

They all have a smooth rubber mantle surface (right in the picture).

All rubber/metal composites with a small rubber rim around the part are okay. There's no need to replace such parts (left in the picture).

Rubber joint safe(left), and unsafe (right)

Meanwhile we found out the reason for the adhesion system failure of singular rubber joints: Our supplier installed a new machine which was used for our lot for the very first time. This machine makes the raw rubber parts. It was lubricated by the manufacturer with oil, which contained silicon.

So some of the rubber parts were contaminated with silicon, and the adhesion system was damaged. Though we don't know about other failures yet we strongly recommend to replace all rubber joints with a smooth surface without any rubber rim prior to the next use.

Until this is finished (see update at the end of this text) **we strongly recommend the immediate change of these rubber/metal composites prior to the next use.**

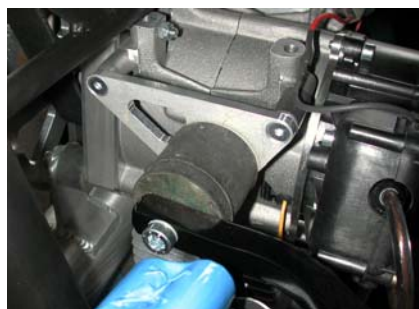
joint @crank case Monster

The larger rubber joints $\text{Ø}50 \times \text{hight } 45$ are used at the crank case of the Monster engine (each has 2 pieces).

These 3 pictures show the location of the rubber/metal joints at the engines. The Flyke uses the 4 joints between the A-frame and the H-shaped engine mount.

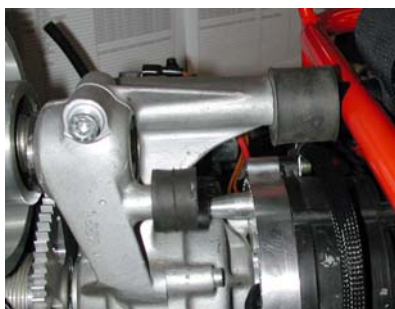
@ gear Simonini

The smaller joints $\text{Ø}40 \times \text{hight } 30$ are used at the engine mount of the Flyke (4 pieces) and at the cylinder head and at the gear of the Simonini engine (max. 3 pcs., typical only 1 at the gear)
